Tsunami Impacts on Coastal Ecosystems of Southern Sri Lanka

Tsunami-Induced Coral Reef and Coastal Ecosystem Damage in the Indian Ocean

Long-term Implications of the Tsunami in Aceh, Indonesia

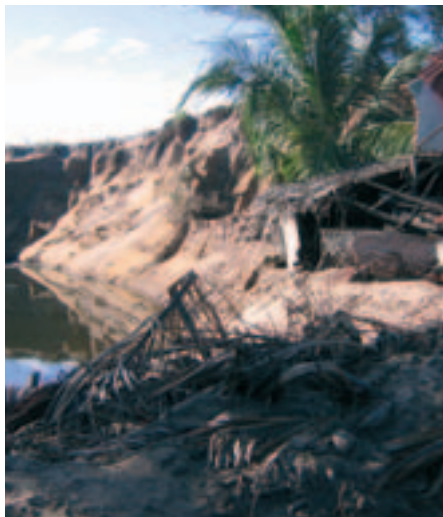
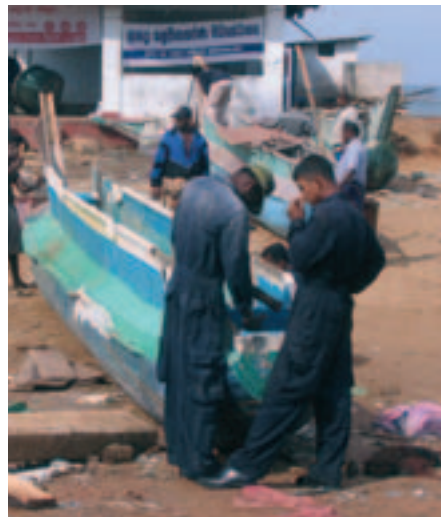
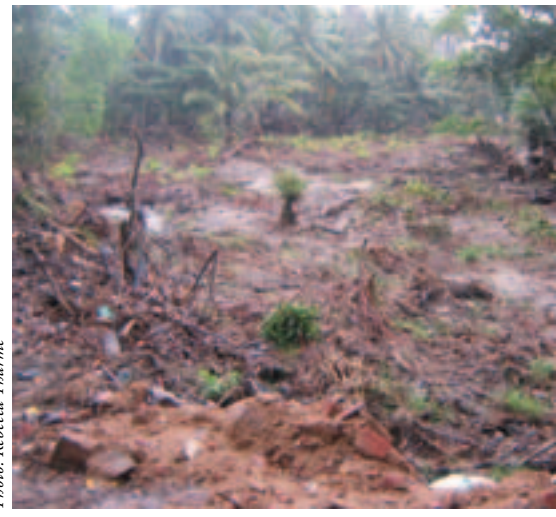
Sand dunes severely damaged by wave action, fishermen repairing boats and small-scale agricultural lands and wetland areas affected by the wave.

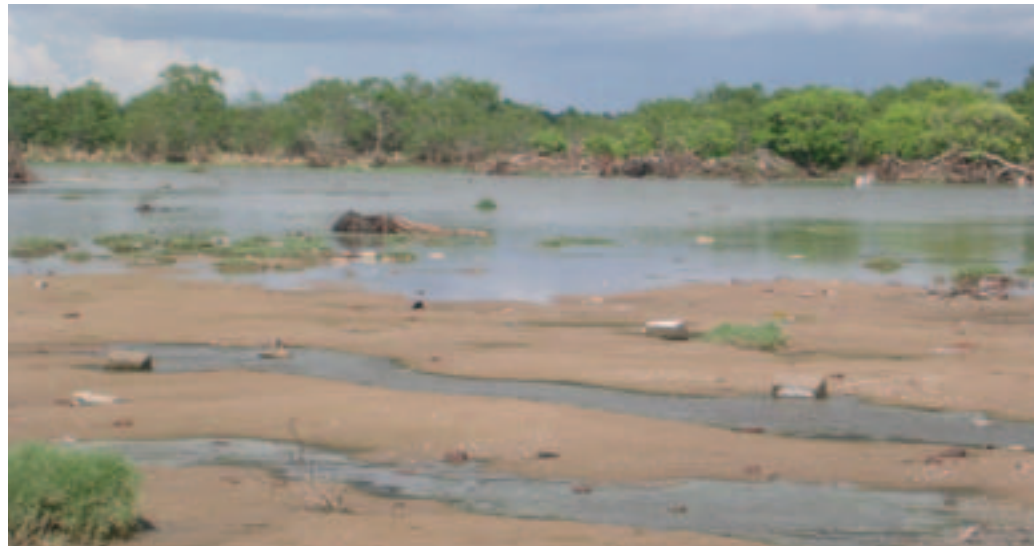
Kalametiya Lagoon, Sri Lanka, with remains of sand bar. The sensitive Mangrove vegetation has been seriously affected.

Kalameiya Lagoon, situated within the Lunama-Kalameiya Sanctuary, a protected mangrove site, was markedly affected and transformed from a closed system pre-tsunami, separated from the sea by a sand bar, into an effectively open system to the sea – part of the sand bar was removed completely and the remaining low bar has the potential to be breached easily, especially a concern with the upcoming monsoon season starting in May (Photograph page 10 bottom). These changes are bound to have long-term ecological consequences. Moreover, as the lagoon was (and remains) an important fishing ground, there are serious livelihoods repercussions for the surviving members of the neighbouring villages.

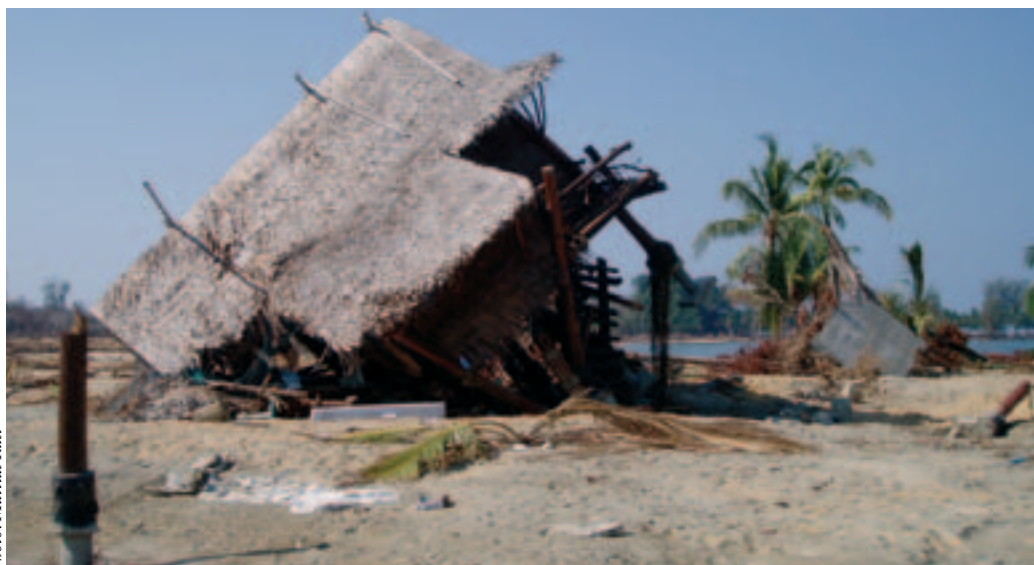
Cottages upturned by the waves.

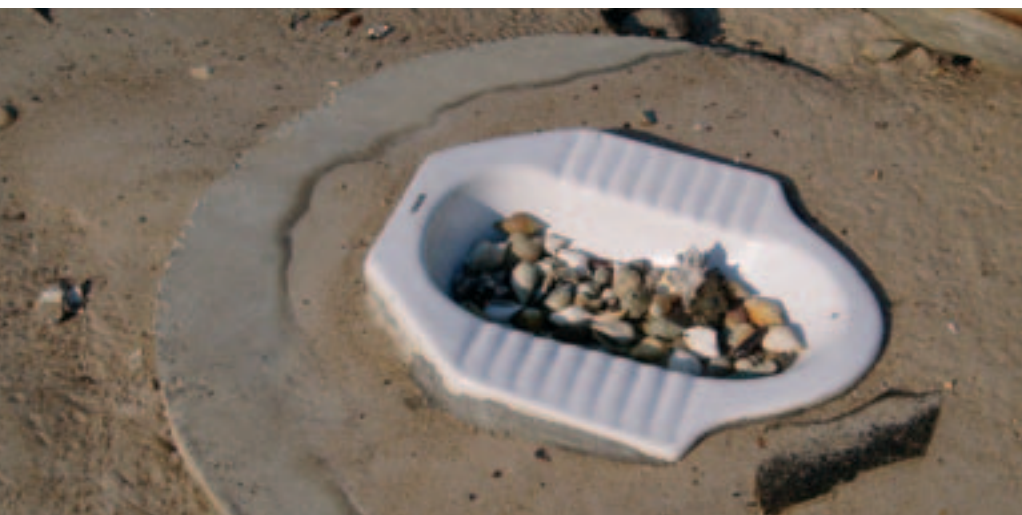
The recovery of water resources infrastructure is critical, including domestic water supply and sanitation. Here, a toilet is visible, partly covered with sand.
